The Locomotive

THE HARTFORD STEAM BOILER INSPECTION AND INSURANCE CO.

VOL. XL

HARTFORD, CONN.
1934-1935

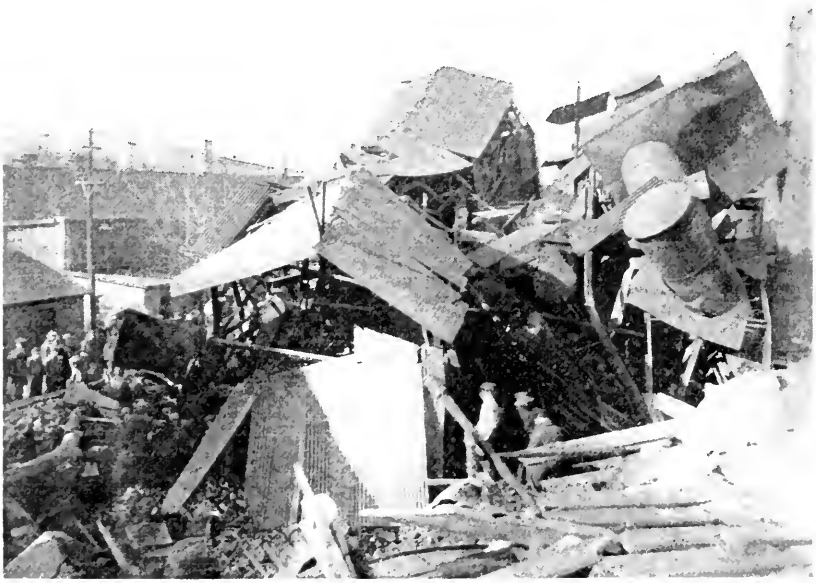
After a corroded mud drum head blew out at an Indiana paper mill.

Investigators were agreed that the boiler had been weakened because of corrosion on the outside of a lower mud drum at the "blind" end of the drum, concealed by the brickwork of the setting, and that this weakening led to the accident. All of the tubes were pulled from the mud drum and the drum itself was thrown a distance of approximately 75 ft, landing on the roof of a paper storage house. Examination of

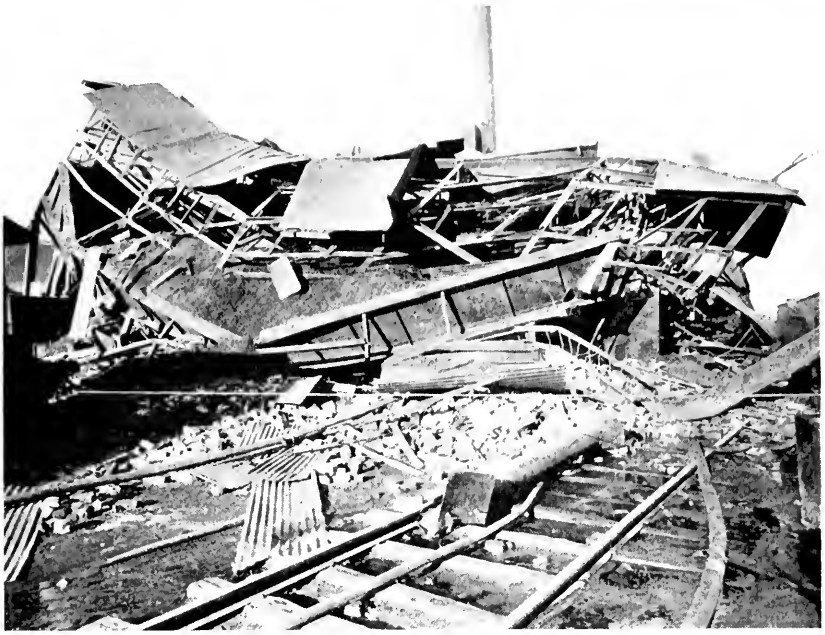
A bunker of coal collapses into the debris to complicate the search for a fireman's body.

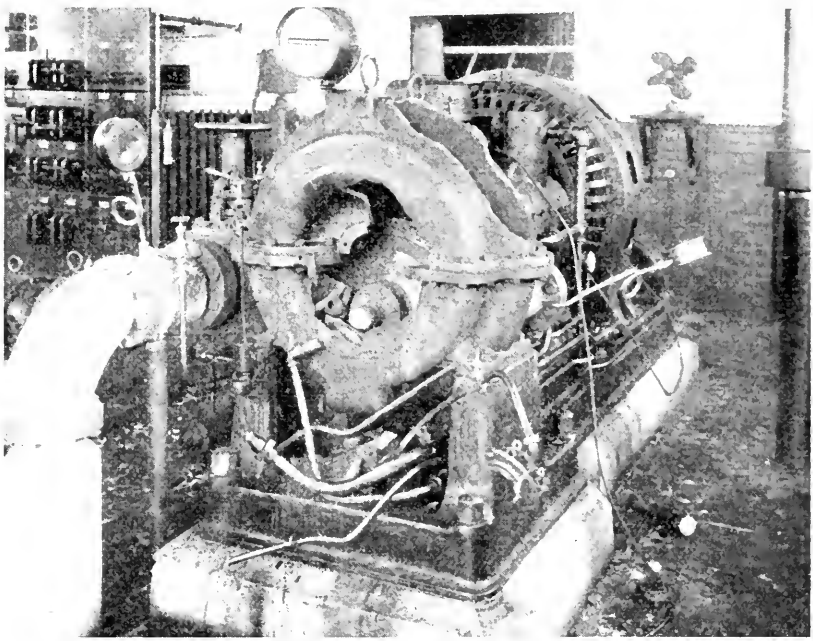
Two men were peppered with flying cast iron when the buckets came through the casing of this turbine. The shaft broke in three pieces during the accident, which was attributed to overspeed.

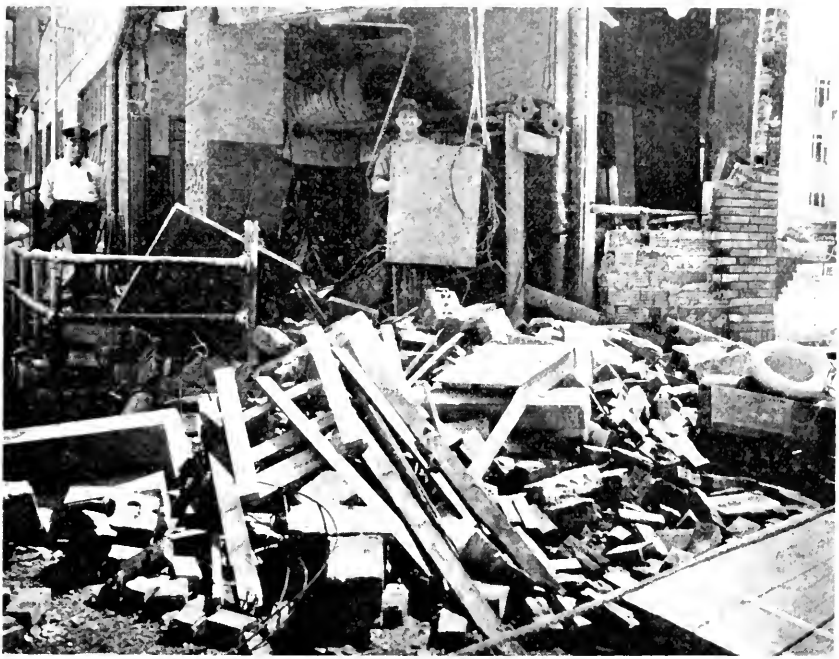
One person was seriously injured and three others received hurts of a minor sort when a coal fired hot water heater burst in the basement of an Indiana service station. The seriously injured man, an

An Indiana automobile service station after a hot water heater burst.

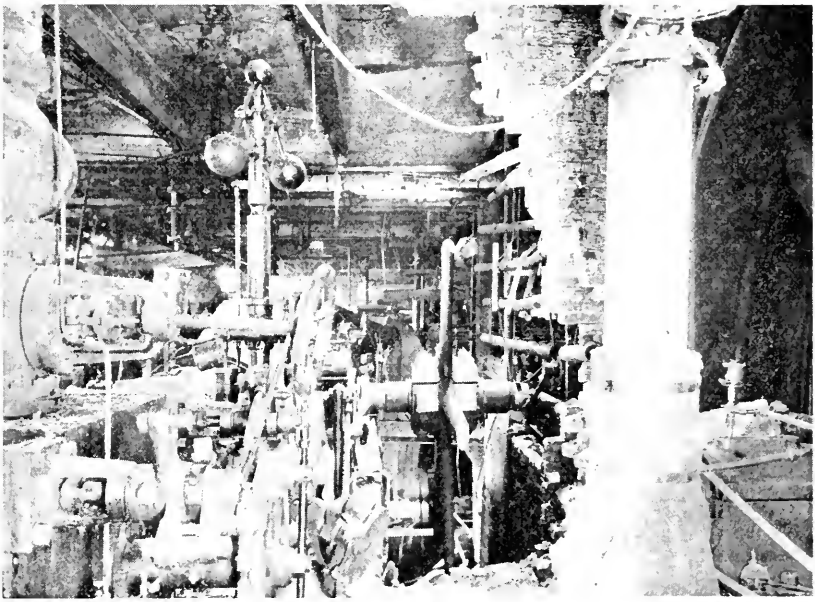
"That whirled the wheel
That burst its rim . . . "

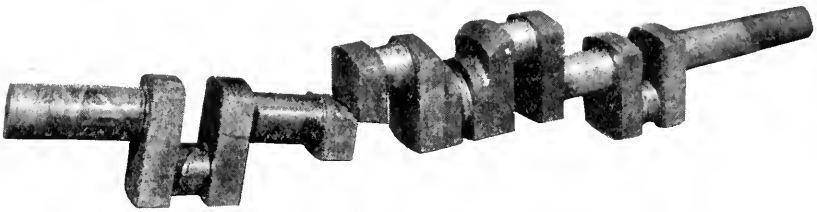
FIGURE 5—*The result of serious over-stresses in a crankshaft caused by bearing wear.*

considerably. Figure 4 shows how the gage is used between the webs of a Diesel crankshaft. The broken shaft shown in Figure 5 shows the baneful result of serious crank distortion caused by worn bearings.

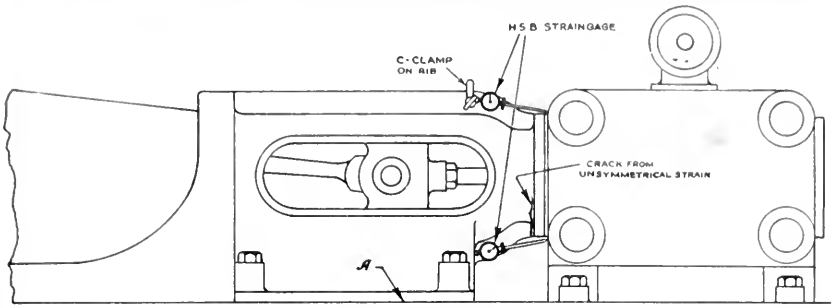
FIGURE 6.

H.S.B. STRAINGAGE
APPLIED TO ENGINE FRAME (WHILE OPERATING)
DIFFERENCE BETWEEN TOP AND BOTTOM READINGS OF
THE STRAINGAGE INDICATES IMPROPER ALIGNMENT, CAUSING CRACKS.

The misalignment that causes the overstress which results in cracking the frame neck, is generally due to softening of the grouting by lubricating oil at "A", Figure 6. In any installation where lubricating oil is allowed to run down the sides of the engine frame and to soak into the foundation, it is certain that serious misalignment will eventually result because concrete and brick become quite soft and compressible when saturated with oil. After some years of operation under these conditions it becomes noticeable that oil is pressed out from under the frame at point "A" when the crosshead moves over that end of the guide barrel, and the oil is drawn in again as the crosshead moves to the crank end. When this occurs it is clear that the engine frame is not being properly supported at point "A" because the grouting has become soft and compressed. The consequence is that the downward force of the crosshead, acting on the guide barrel, is transferred through the frame neck to the nearest support under the cylinder which produces a bending action in the frame neck that is almost certain to result in a cracked casting. An example of the results of unsymmetrical strain in the frame neck is shown in Figure 7.

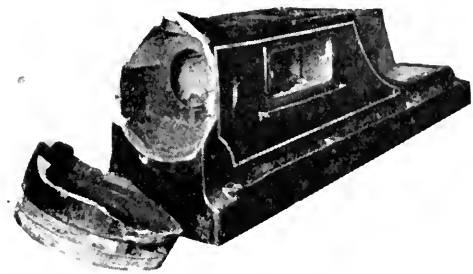
FIGURE 7—*Result of crack in engine frame neck caused by unsymmetrical strain.*

The vertical movement of the frame at the point where the grouting has become compressed has given some operators the erroneous impression that the nut of the nearest foundation bolt had worked loose. Tightening of the foundation bolt nut under such circumstances, while the engine was running, put such a severe bending stress in the frame neck in a few cases that it was only a matter of minutes before a long crack had formed. The tightening of foundation bolts of engines should never be undertaken without first carefully analyzing the real cause of the looseness of the bolts. The looseness as pointed out in the foregoing, may be the result of the softening of the grouting. If so, a re-aligning of the castings on the foundation and regrouting is necessary before the foundation bolts can be properly tightened.

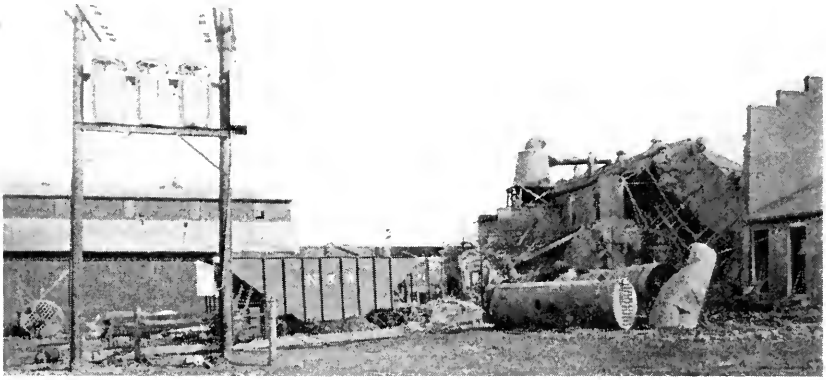
Another view of the mill at Hertford. In the foreground is No. 3 boiler and part of the stack. The front course of No. 2 boiler is shown at the extreme left where it fell after the explosion.

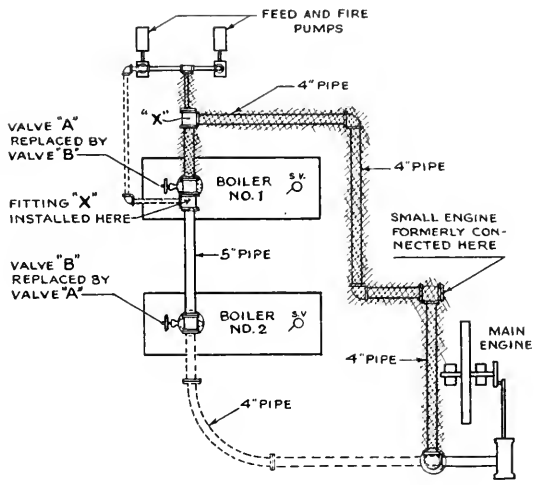
The general layout as he found it, was as shown in the cross-hatched portion of the accompanying sketch. The length of the piping between the boiler outlets and the engine consisted of 7 ft of 5″ piping and 60 ft of 4″ piping, making a total of 67 ft. In this length of pipe were 4 elbows and 2 tee fittings. Figuring that the resistance to the flow of steam due to the presence of 6 right angle turns would be about equivalent to the frictional resistance set up by the addition of 96 ft of 4″ diameter piping, he concluded that in its passage from the boilers to engine the steam actually met with frictional resistance equal to that which would be set up by 163 ft of 4″ diameter pipe.

To determine the pressure at the commencement of the engine stroke, an indicator card was obtained. The inspector had anticipated a noticeable drop in pressure but he had not expected to find that with 82 lb pressure on the boiler gages, the pressure in the engine cylinder would be only 67 lb. At the inspector's suggestion, the assured obtained the long-turn bend shown in the sketch and had it installed over a week-end. Furthermore, the piping in its entirety was adequately clothed with insulating material. On the following Monday morning the safety valves were set to release at 78 lb and when the engine was again indicated the card showed an initial pressure varying between 70 and 72 lb. Greatly to the satisfaction of every one, the engine was found capable of carrying the load quite comfortably.

With the exception of a 4″ long-turn bend and the insulating material, the piping and fittings in position at the time of the investigation were utilized in a changed position. The indicator had brought to light evidence of a slight leakage of the engine admission valves, so

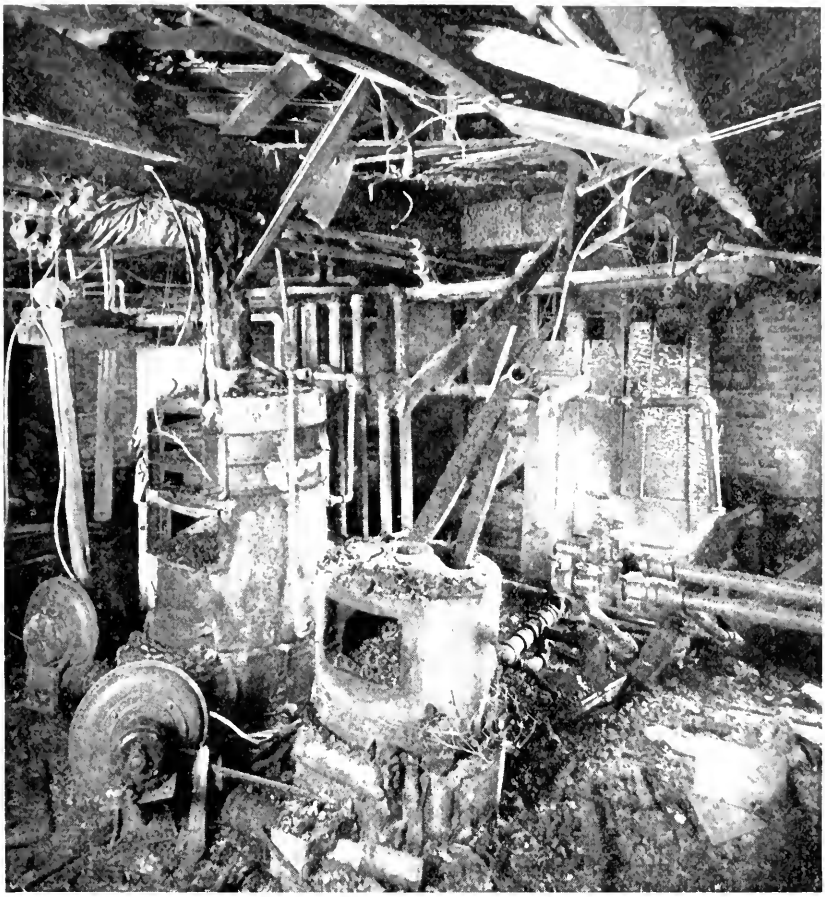
RESULT OF HEATING PLANT VIOLENCE

WHILE all available evidence indicated that an accident to cast iron sectional boilers used in an Ontario residence was due to the explosion of furnace gases, the investigators found it difficult to understand why the top section of the right-hand boiler was so badly shattered. The boilers were used in connection with a hot water heating system. The top section of the smaller boiler went through two floors, hit the ceiling in the upper room and came to rest across the foot of the bed in which the housekeeper was sleeping. The opinion was expressed that internal steam pressure must have developed to some extent at least in a manner which available evidence did not make clear. No boiler insurance was carried.

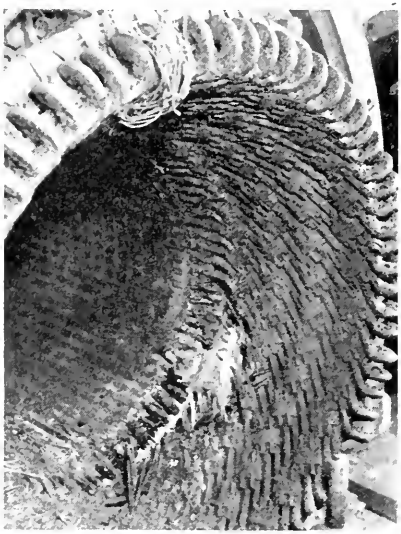
THE generator end of a 5,000 kw turbine, operating at 3600 rpm, broke down on June 2, 1933, in the municipal power plant of Austin, Texas, and caused damage in excess of $6,500. The burn-out was attributed either to a phase-to-phase short circuiting with subsequent damage caused by a balancing plug in the field becoming loose and protruding far enough to gouge out the coils of the armature, or else to the entrance of some foreign metal into the generator winding.

After Generator Burnout.

A small steel object resembling a part of a ½" bolt was found close to the radial end ring.

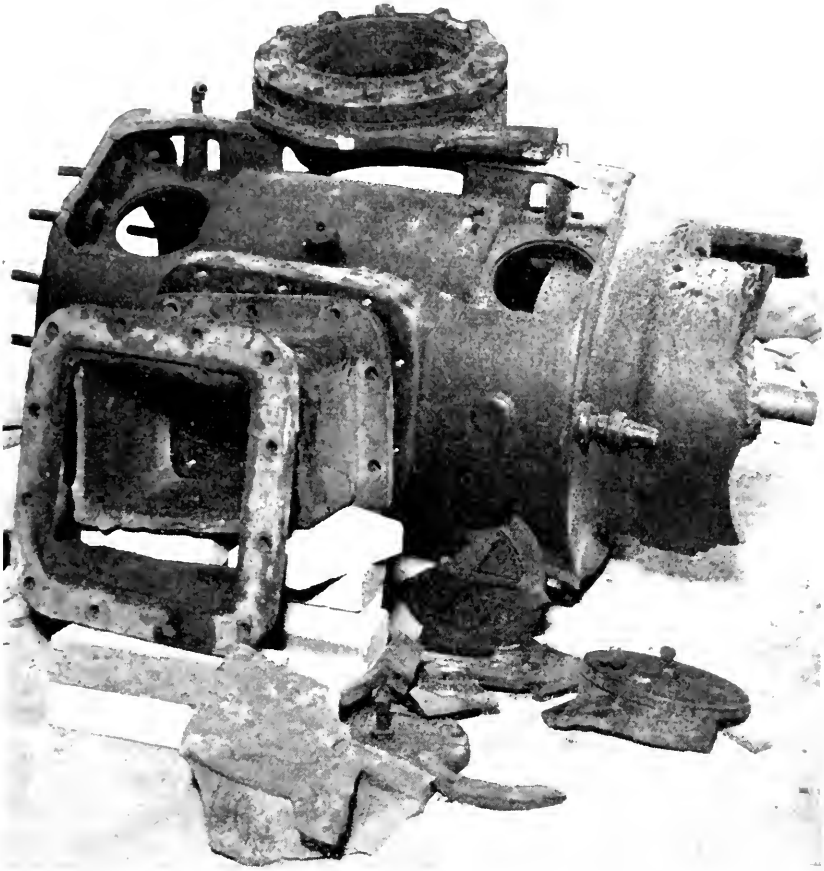
High pressure cylinder of an air compressor demolished by explosion of a mixture of oil vapor and air.

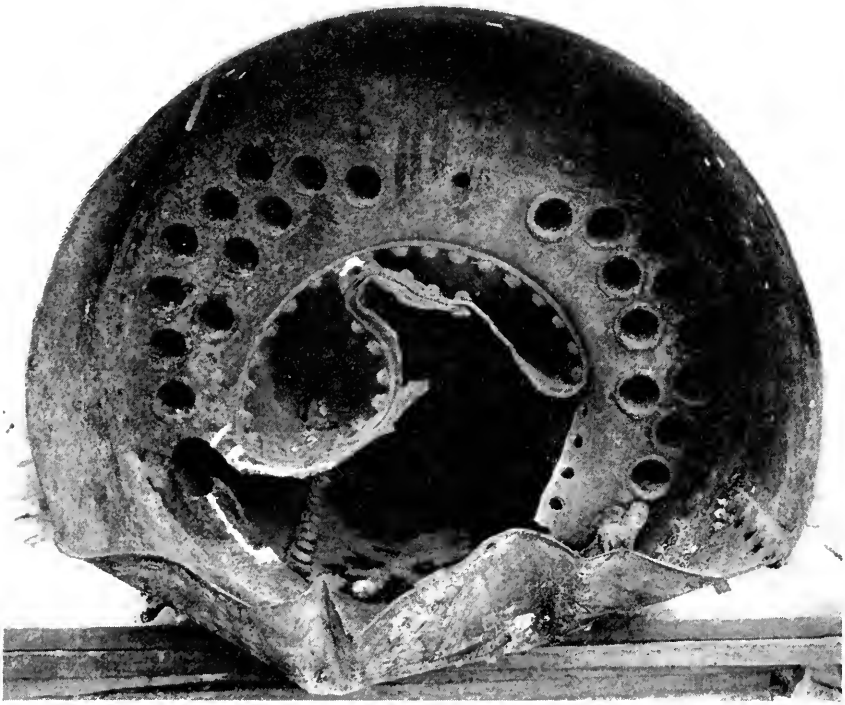
Caused by corrosion and over-pressure.

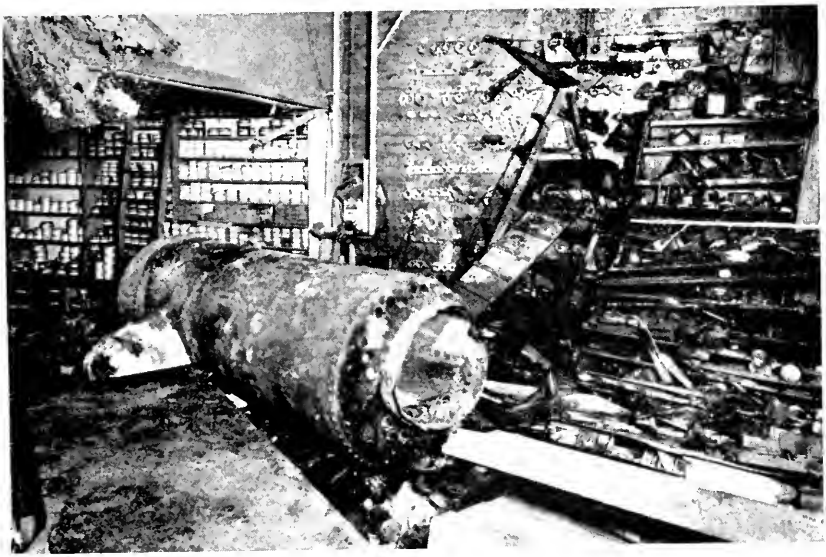
The 38" diameter boiler, where it landed in a neighboring store.

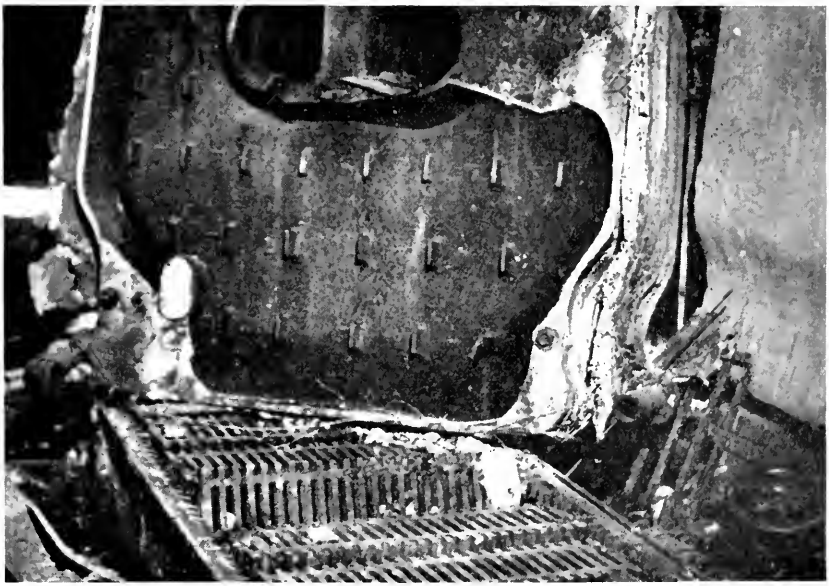
Church's cast iron boiler weakened by broken stays.

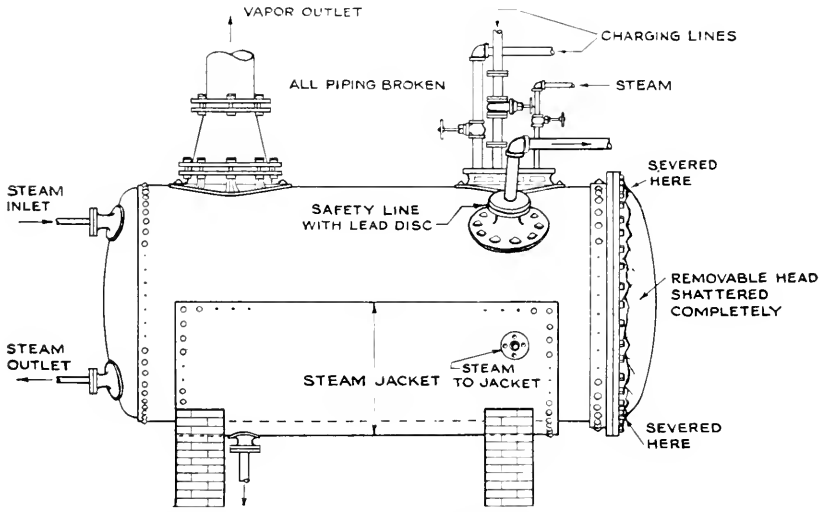
Figure 1—Diagram of still showing steam lines and head which failed.

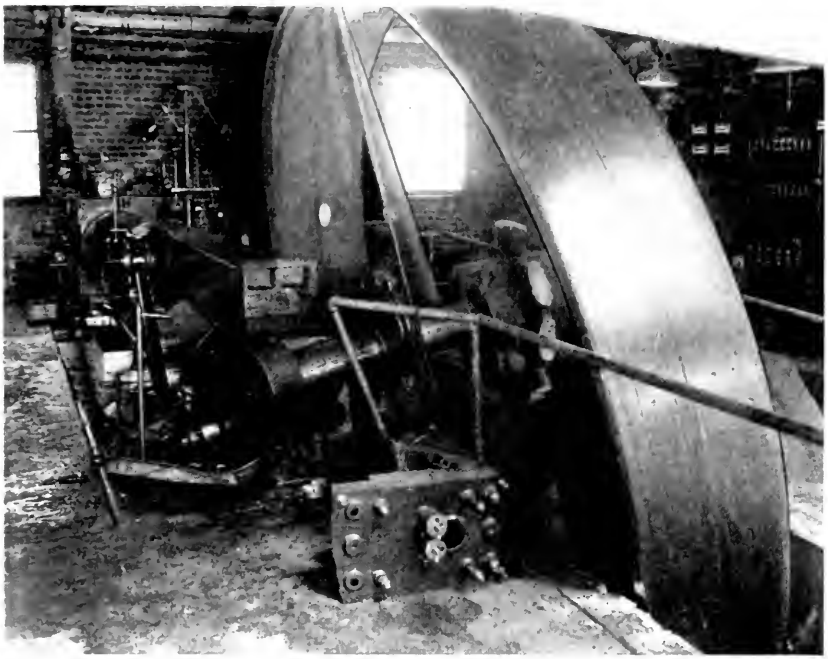
A 350 hp single-cylinder steam engine with a 15′ flywheel was totally wrecked on September 7, 1934, at a Virginia trunk manufacturing plant. The operator had stepped into the adjoining boiler room, when the crash occurred. By the time he had reached the engine it had come to a sudden standstill—in the condition shown in the photograph.

The engineer heard a crash; he returned to this wreck.

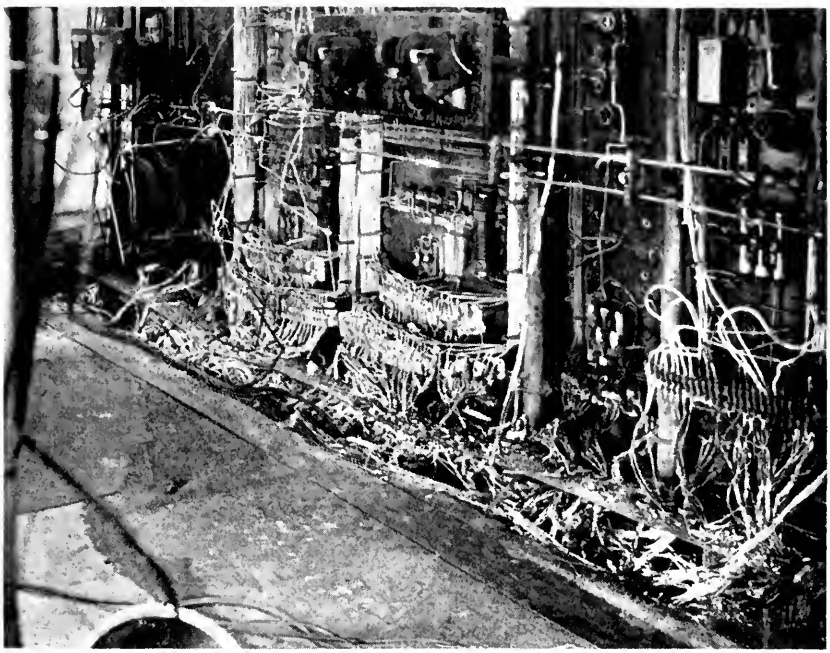
Switchboard wrecked by a short circuit and fire.

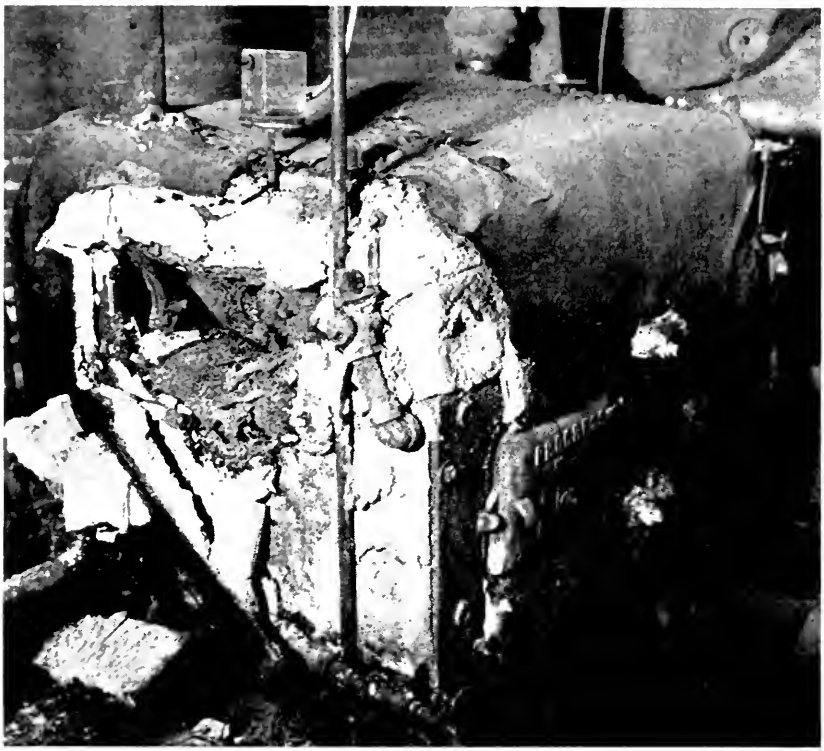
After the boiler drained the oil burner kept on operating. The sections were fused into a shapeless mass.

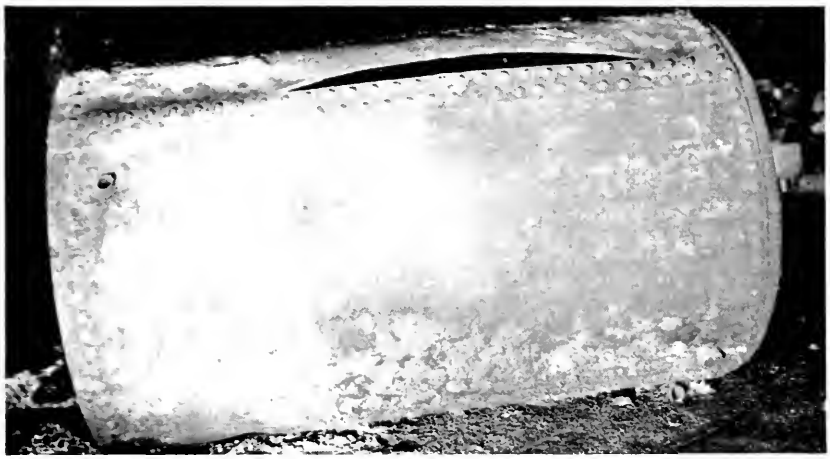
Lap seam crack inconveniences utility.

from its setting and projecting it across the boiler room. The accident caused little damage except to the boiler itself. The nature of the failure may be seen in the accompanying photograph. Following along the edge of the inside lap a distance of 41", the rupture extends from about 7½ inches below the top head seam and to within about 3 inches of the top staybolt. The boiler was under pressure of about 40 lb of steam at the time of the accident.

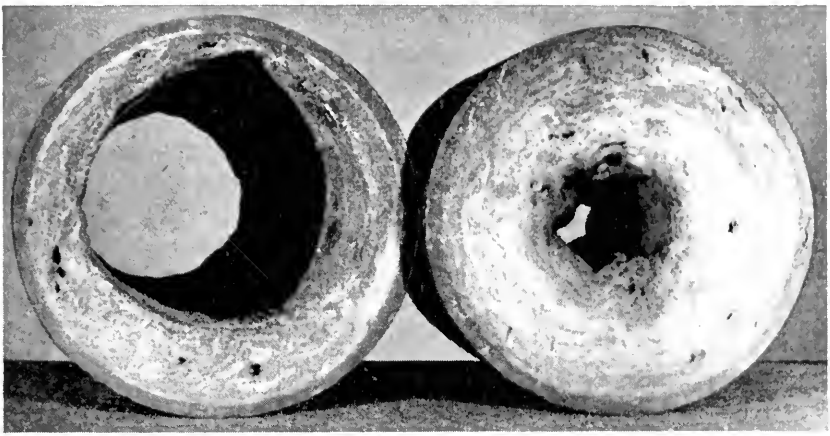
An extreme example of scale in boiler tubes.

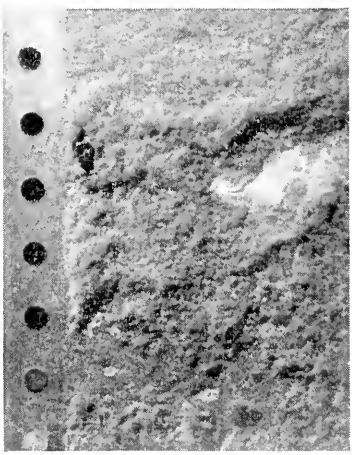
The result of corrosion.

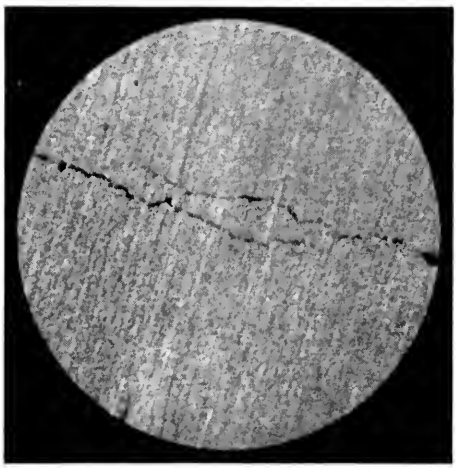
There are still some differences of opinion concerning the fundamental cause, or causes, responsible for the form of failure of boiler steel which is now commonly known as "embrittlement", or more frequently as "caustic embrittlement". However, the condition is invariably accompanied by the presence, in the boiler water, of sodium carbonate, which, in the absence of neutralizing sulphates or certain other substances, and in the presence of heat and pressure, leads to the formation of sodium hydroxide. It is quite generally agreed that two conditions must be present simultaneously to produce "embrittlement": First, the high concentration of sodium hydroxide in the seams or under the rivet heads; and second, stressing of the metal to about the yield point. It is an established fact that the zone of greatest stress in fabricated boiler seams is in the riveted area, and it is there that deterioration of the boiler steel, resulting from "embrittlement", occurs.

"Caustic embrittlement" under the Magniscope.

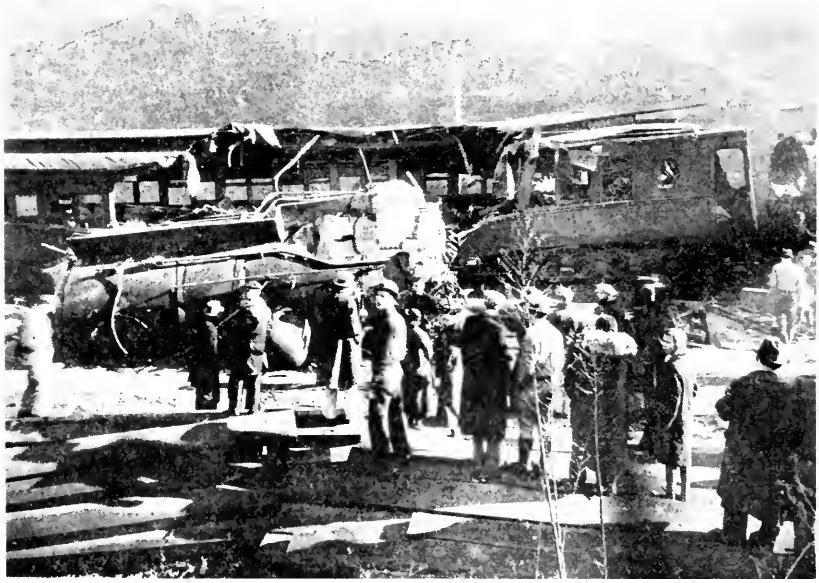
Where 16 miners lost their lives in locomotive boiler tragedy.

Failure, which was attributed to low water and overheating, evidently occurred in the crown sheet, the released steam tearing off the engine's smoke box cover and hurling it into the first car, which was coupled to the front end of the locomotive. Simultaneously the boiler was blown up into the air, and came down in the center of the leading coach, tearing away the top and one side. The cab was hurtled through the roof roof of a nearby house.

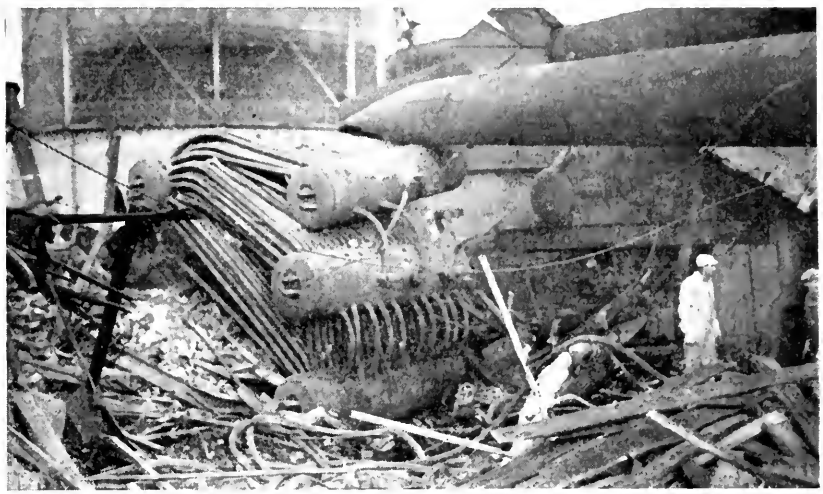
The explosion was attributed to the failure of the concealed head

Wreckage after failure of concealed mud drum head.

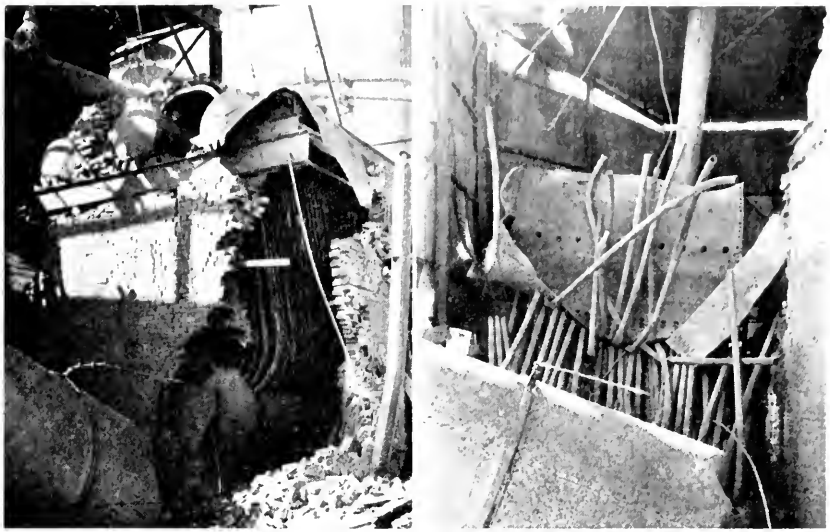
Damage from explosion of water tube boiler after seam failed.

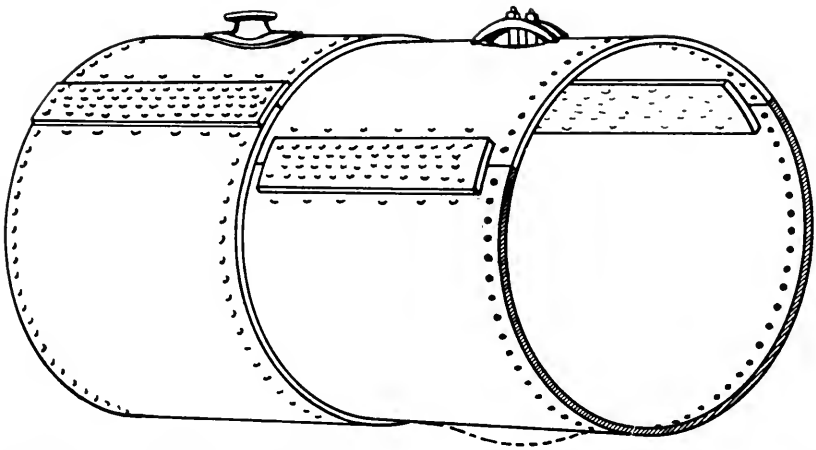
Figure 1—Repair of a bulge caused by overheating because of an oil deposit on the plate.

When a new fire sheet is installed, the longitudinal seams must be located well above the fire line. It is good practice to attach the new

sheet on one side at the original longitudinal seam of the course. On the other side the new seam should be located so that it will "break joint" with the longitudinal seam of the adjoining course, that is, the two seams should not be at the same point on the circumference of the boiler. (Figure 1). The cost of a repair of this kind, when made with the boiler in place, may exceed the cost of putting on a complete new course at a well equipped boiler shop. The expense of removing the boiler from its setting, shipping it to and from the boiler shop, the repair work (which is likely to include a number of new tubes), and the reinstallation of the boiler will probably equal, if not exceed, the cost of a new bare boiler. All of these factors, in addition to the question of safety, must be taken into consideration when deciding upon what repairs to make and how to make them.

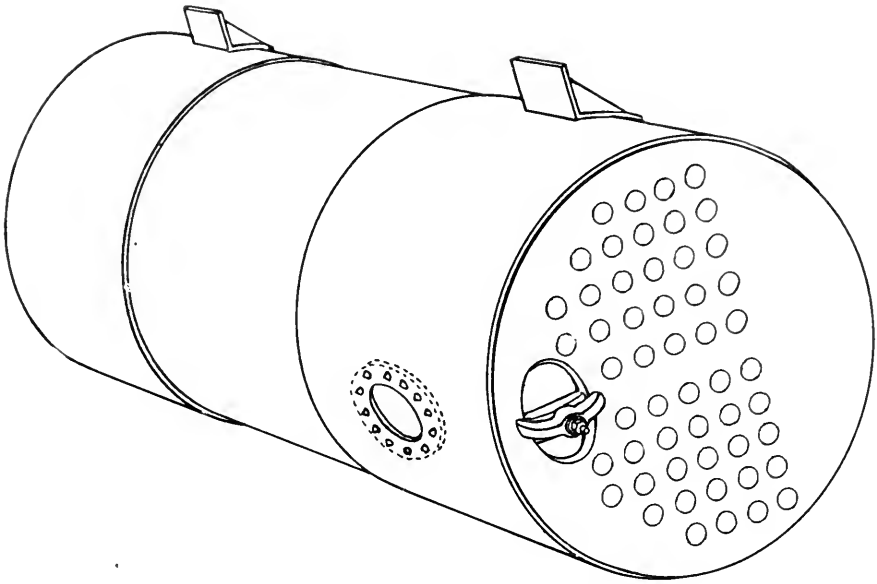
Figure 3—Repair of a bulge caused by overheating because of scale.

If the depth of such a bulge is not more than 25% of its diameter, it may be possible to restore the plate to practically its original shape by proper heating and hammering. Even if there is no rupture at the apex of the bulge it is well to drill a hole of about 1" diameter at that point in order to determine the thickness of the plate and to facilitate the upsetting of the bulged metal. A welding torch, secured to a long

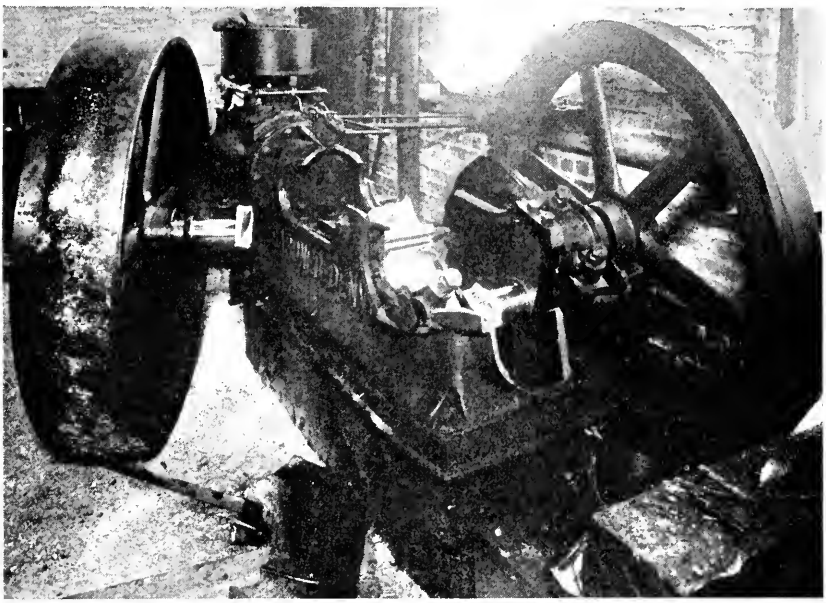
AN old and originally small flaw in the metal gradually extended in the crank of an air compressor at a North Carolina mill until the crank could no longer sustain the load and broke suddenly with the result shown in the accompanying photograph. The break caused a

An air compressor wrecked when the crank broke as shown.

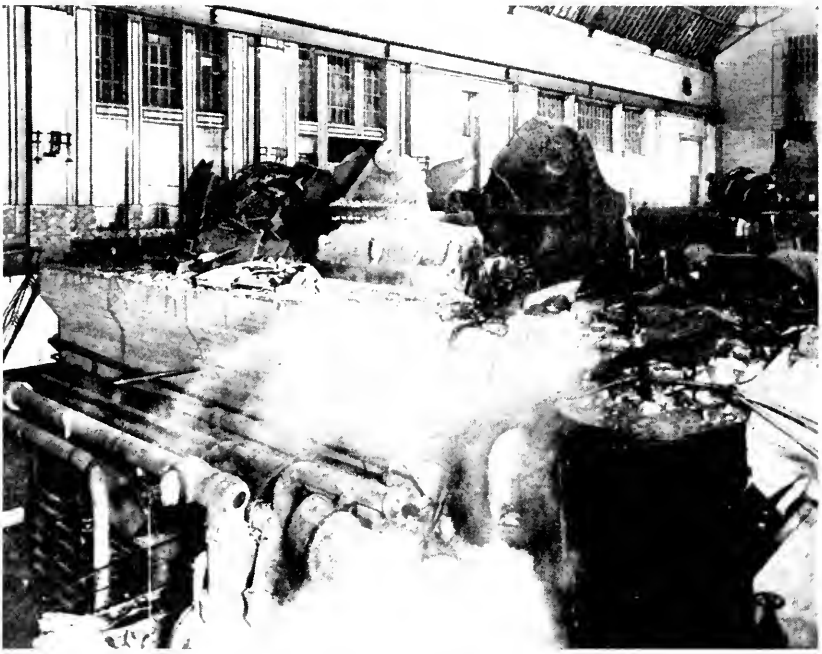
photograph of a turbine that exploded some months ago in a power station at Stettin, Germany. This 23,000 kw unit was undergoing a 10 per cent overspeed trial when it let go, severely injuring two attendants and causing damage estimated at $200,000.

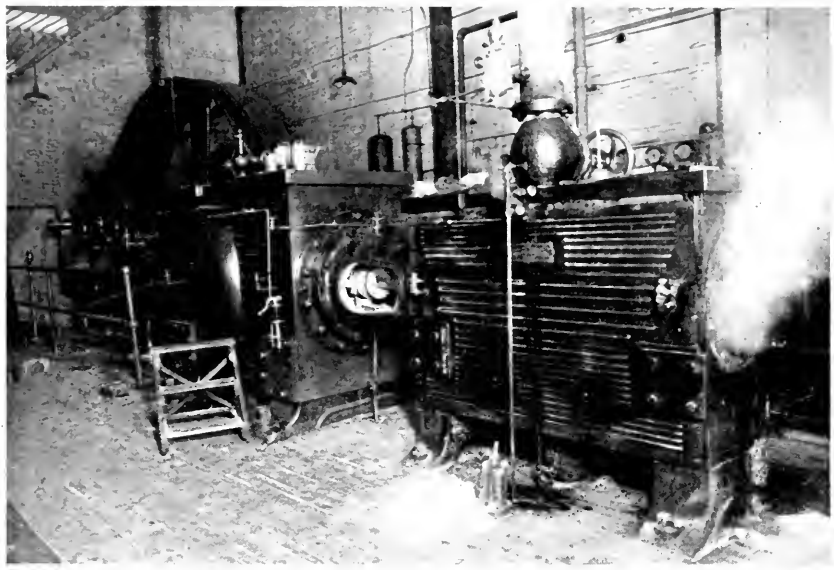
HOW the failure of a minor part can bring about a complete breakdown of a reciprocating engine was illustrated some weeks ago by an accident at a New York worsted mill. The engine, a 500 hp tandem compound unit, was operating normally when the gib in the crank end of the connecting rod broke, permitting the rod to

What unharnessed reciprocating parts can do to a steam engine

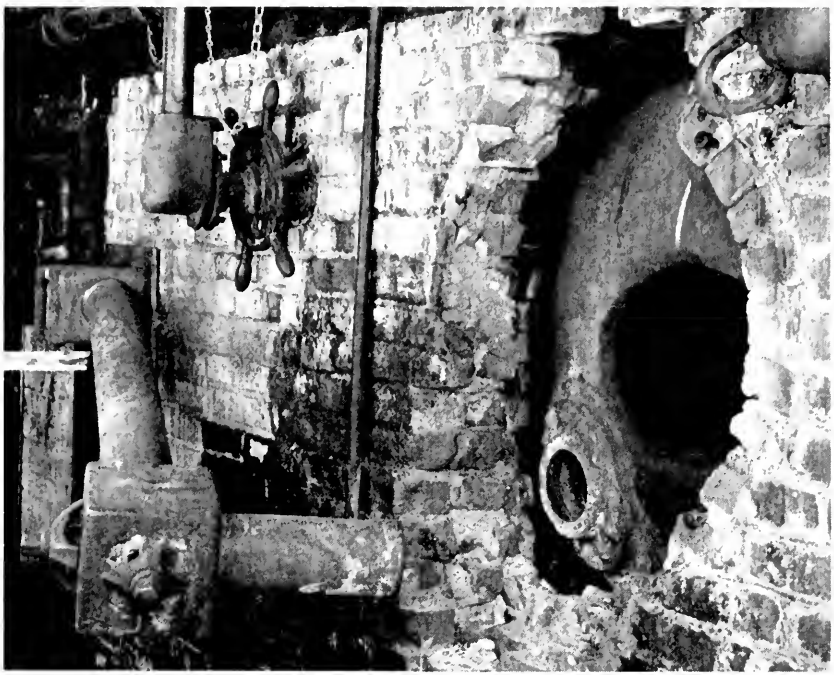
When a 5″ circulating tube between the lower drum of a bent tube type boiler and a water back pulled loose from the drum on March 21, 1935, at an Indiana plant, two men who sought to leave the boiler room were fatally scalded. They were working on another boiler about 100 feet away from the circulating tube and tried to get out of the building in the confusion following the release of the steam. Besides

Circulating tube which pulled out of drum. Prompt drawing of the fire prevented serious overheating of the draining boiler.

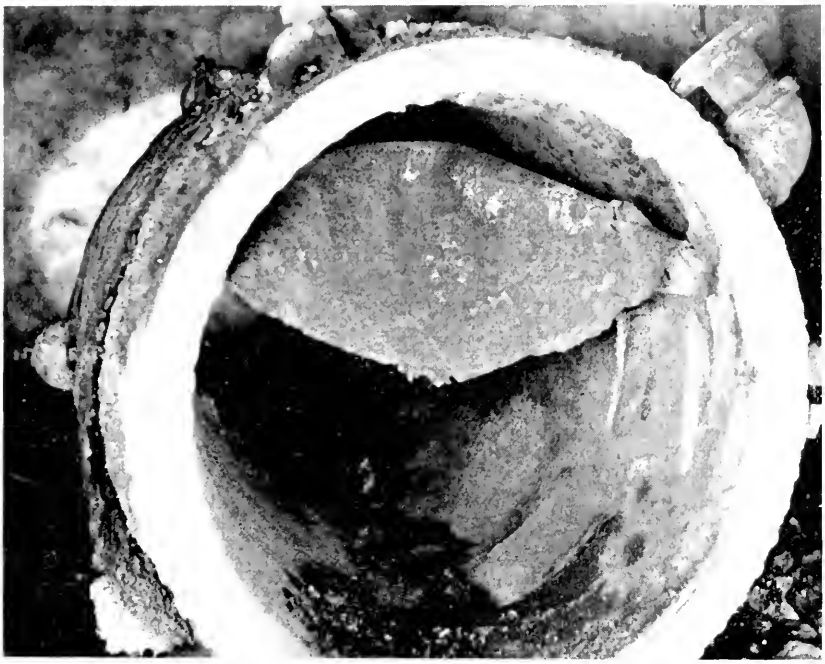
The boiler had been so wasted by pitting and grooving that in places its furnace sheet was scarcely thicker than paper. When this fire sheet

An accident clearly attributable to corrosion.

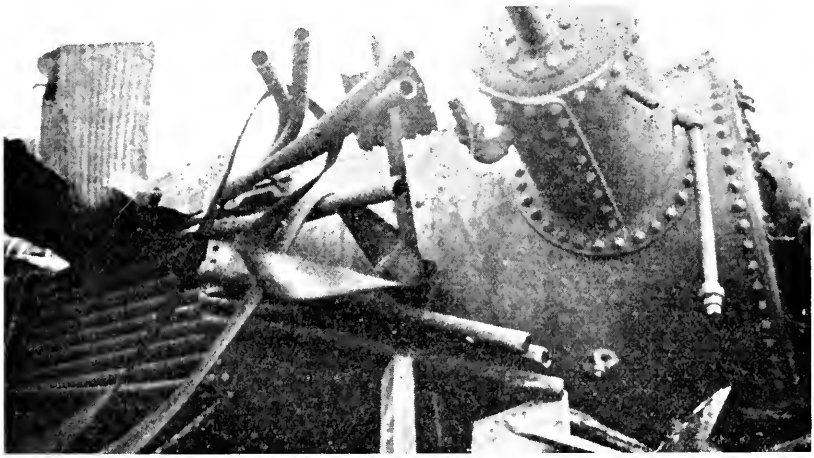
This boiler caused the wreckage in the picture at the top of the page. It is a dry back marine type and was mounted on wheels. An investigation revealed that the accident was caused by the cracking of the shell plate along the edge of the inside butt strap. The plate gave evidence that there was an old interior crack which had spread through the plate as the result of flexing action. The force of the explosion hurled the boiler about 25 feet.

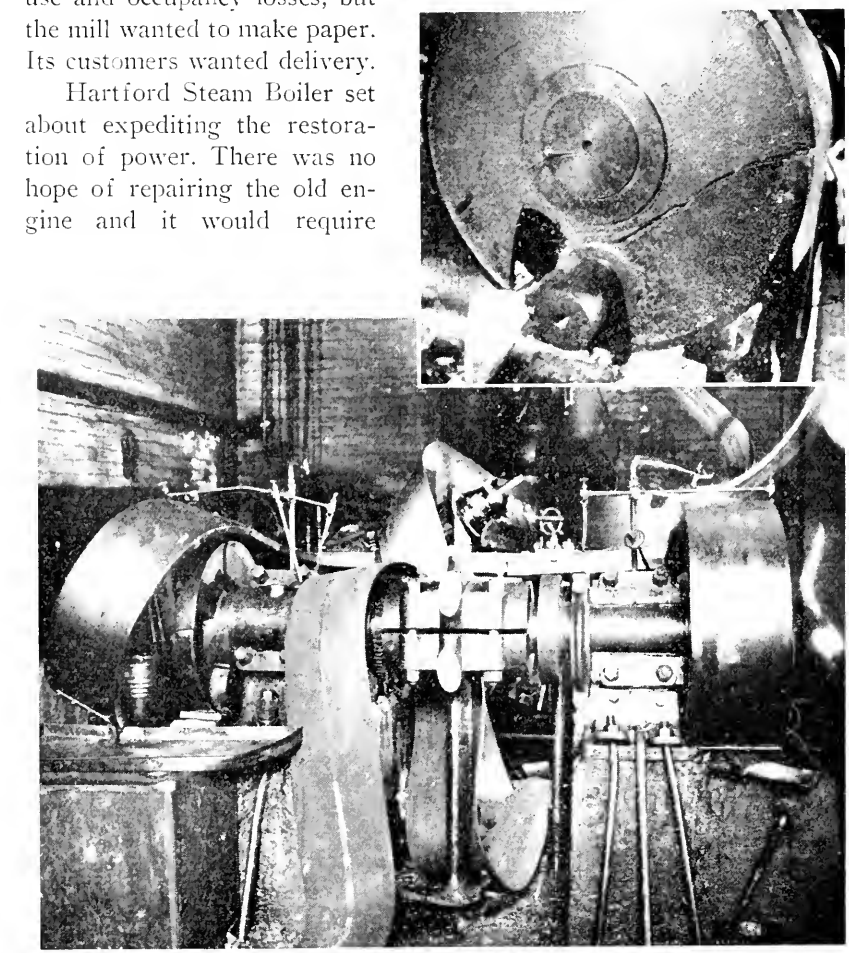
Spoke stumps and a tangle of belts and machinery after the engine stopped suddenly. Above—The cracked crank disc.

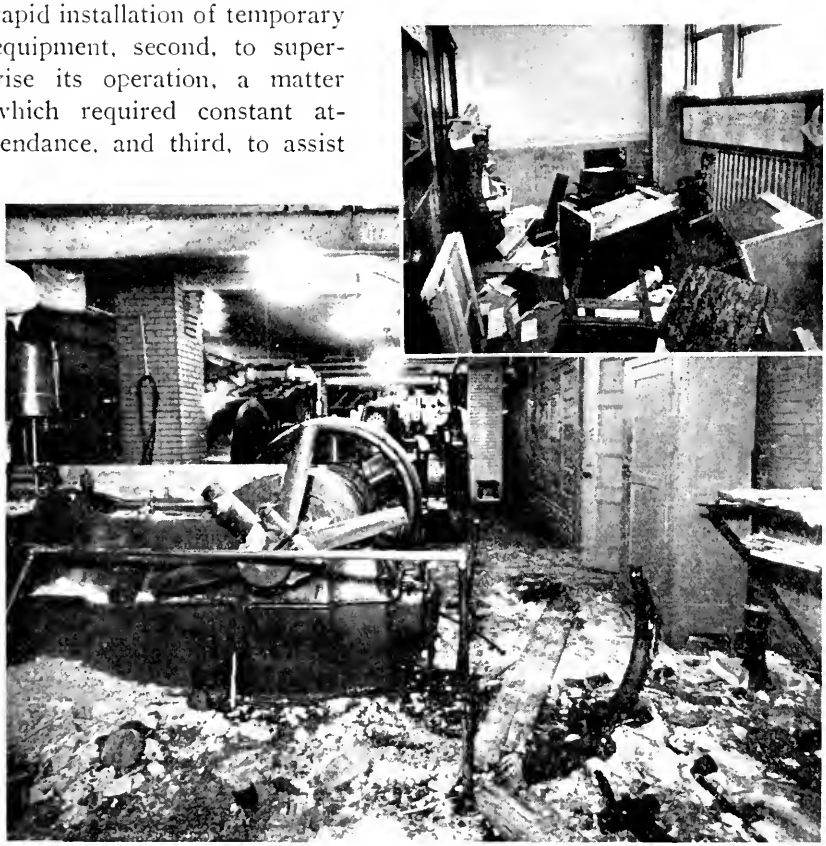
Only the spokes remain. Part of the wheel jarred the room shown above by heaving the concrete floor.

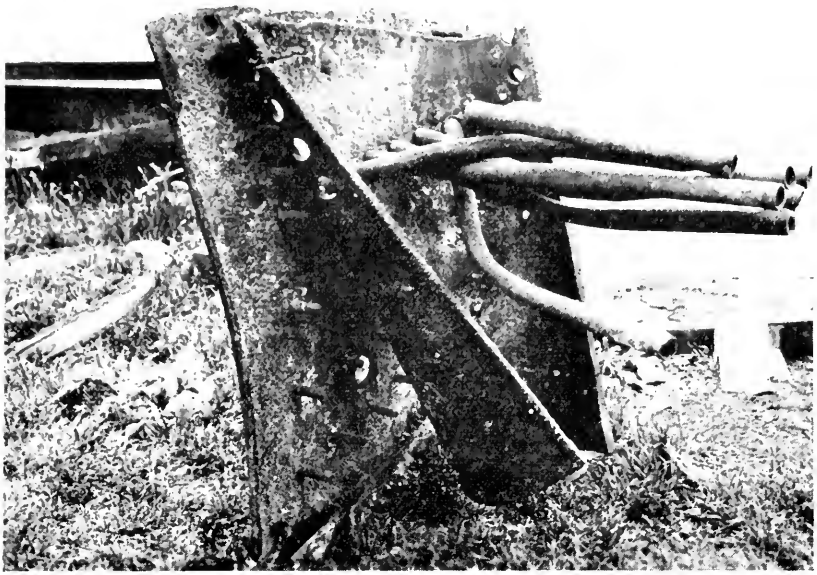
Once part of a hot water supply system.

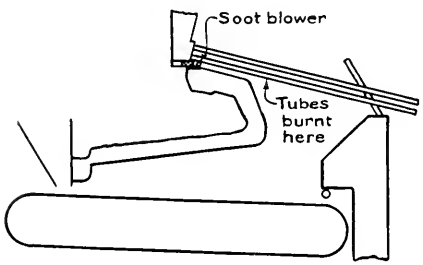
Repeated burning out of the bottom-row tubes in a battery of water tube boilers caused much speculation at a Springfield, Illinois, plant. Failures always occurred at some distance from the front header, and looked as if a blow-torch had been directed on the tubes. The trouble, according to Julius Brodsky in *Power*, was traced to the soot-blower. The arrangement of the soot-blower steam jets was such that it was impossible to keep an air seal between the bottom of the header and the ignition arch. With air flowing through this opening and contacting unburned gases from the furnace above the back end of the ignition arch, combustion occurred with blow-torch intensity and damaged the tubes. The soot-blower arc of travel was changed so that steam would not impinge on the header, and an air seal was provided under the front header by laying a row of brick, caulking with asbestos rope and finishing with asbestos fire-clay plaster. Provisions were also made for admission of additional air over the fire, so as to complete combustion of gases before they struck the tubes. After correcting the conditions, no further tube failures occurred.

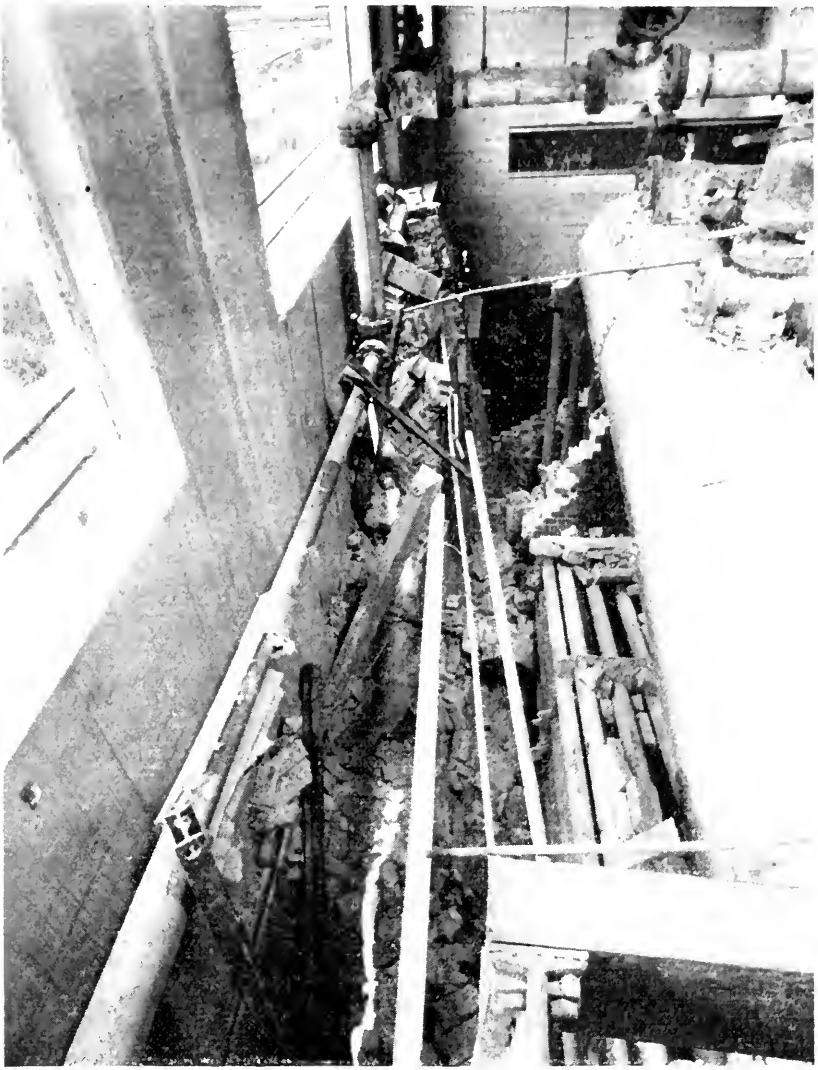
Brick masons worked night and day to rebuild this setting.

had not presented itself. In any gas-fired installation the pipe to each burner should be provided with a straight-way plug cock marked in line with the passage, and there should be a rising spindle gate valve or some equivalent device which indicates positively whether the valve is open or closed, and which can be seen from a distance.
